Demolition of the Fixed Service Structure FSS and Rotating Service Structure RSS, Launch Complex 39B at the John F. Kennedy Space Center, Florida.

**LIMITED ASBESTOS INSPECTION  
FOR THE  
DEMOLITION OF LAUNCH COMPLEX PAD 39B  
AT  
JOHN F. KENNEDY SPACE CENTER, FLORIDA**

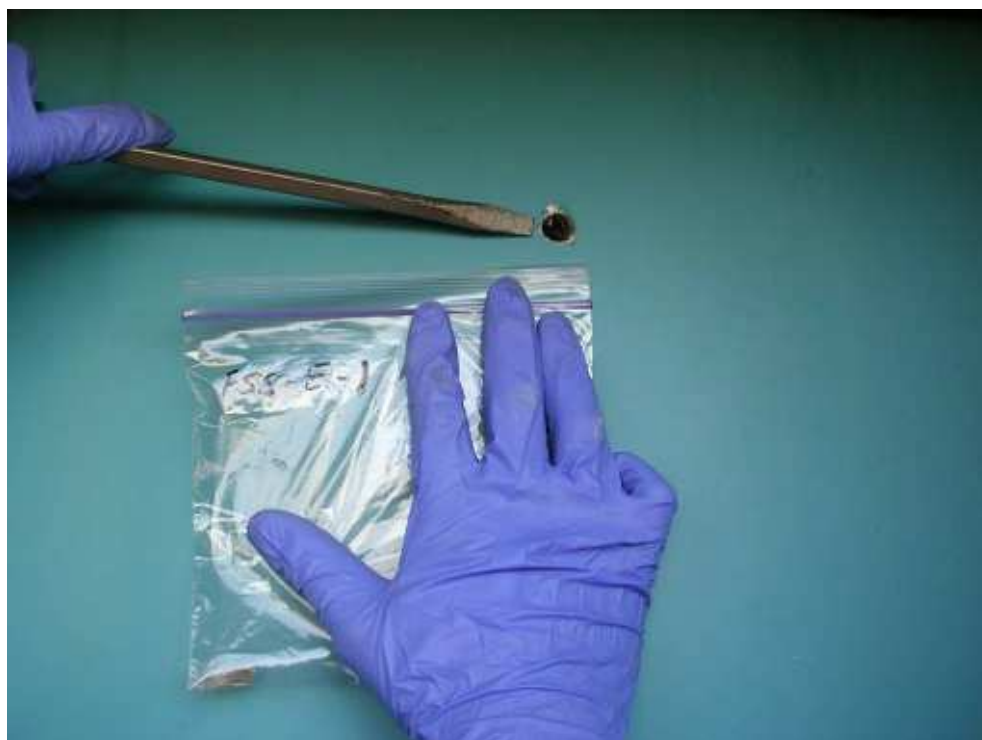
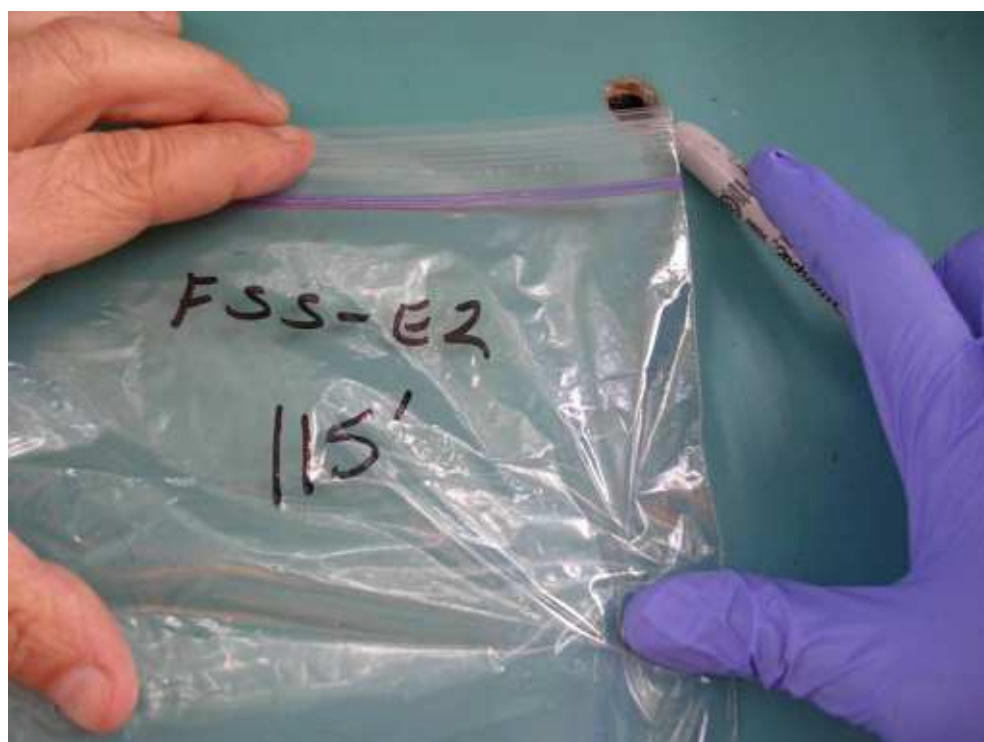
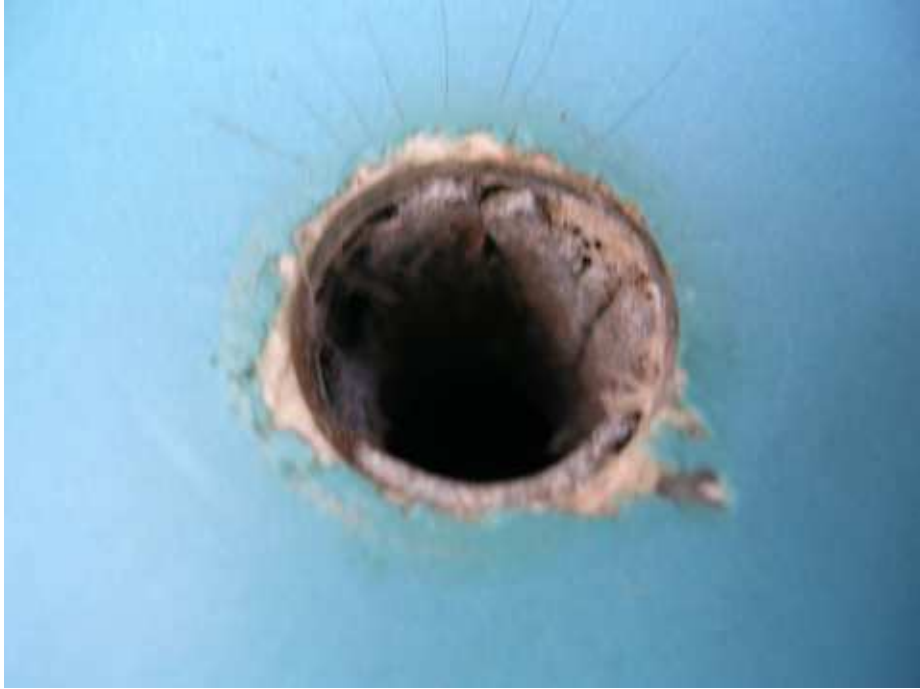
FSS Pad Surface, LVL 115

PROJECT NAME	<u>Launch Complex 39B</u>	Project #:	<u>14005-006-01</u>
INSPECTORS	<u>Javier Du Quesne, Tom Murray</u>		
Project Date:	<u>March 26, 2009</u>	Report Date:	<u>June 2009</u>
Inspection Location:	<u>Launch Complex 39B</u>		
Sample Location:	<u>Fixed Service Structure</u>	Est. Quantity:	<u>800 SF</u>
Homogeneous Area No.:	<u>2</u>	Sample No.:	<u>E-1, E-2, E-3</u>
Material Type:	<u>Elevator Doors</u>		
Description	<u>Fiberglass, Epoxy</u>		
% Asbestos:	<u>N/A</u>	Type Asb.:	<u>N/A</u>
Asbestos Response Priority:

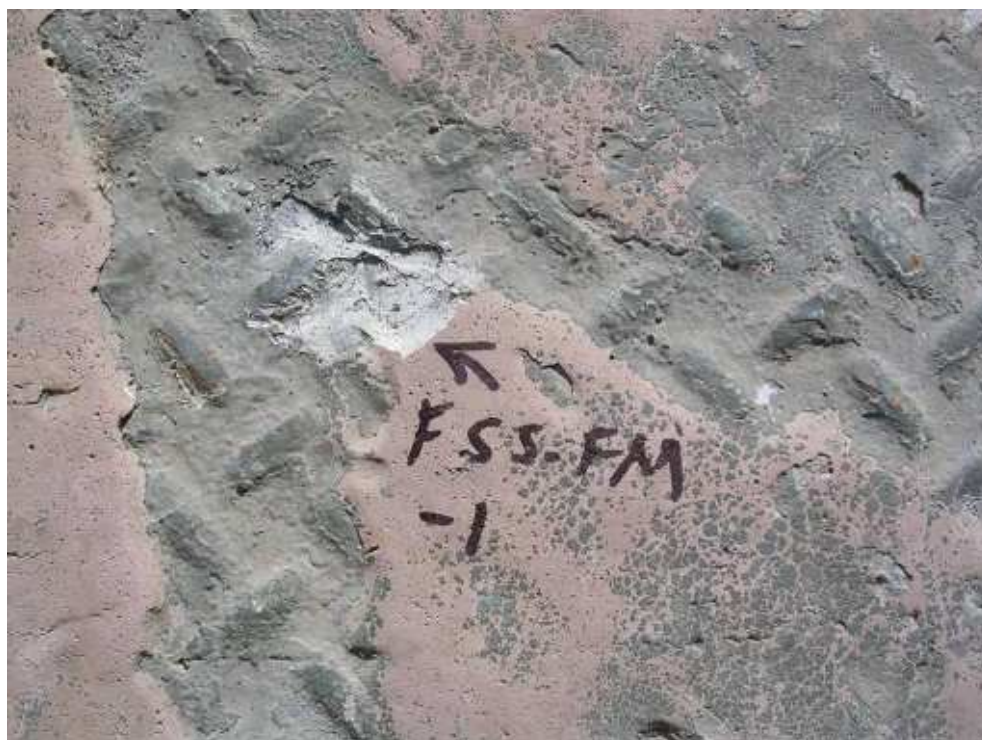
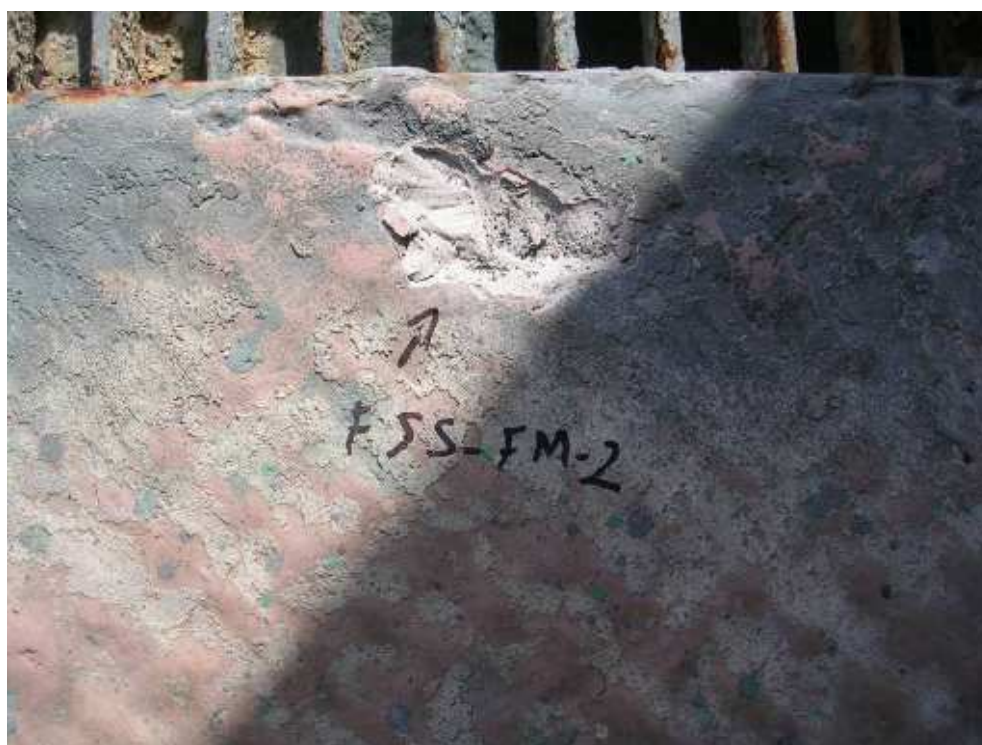
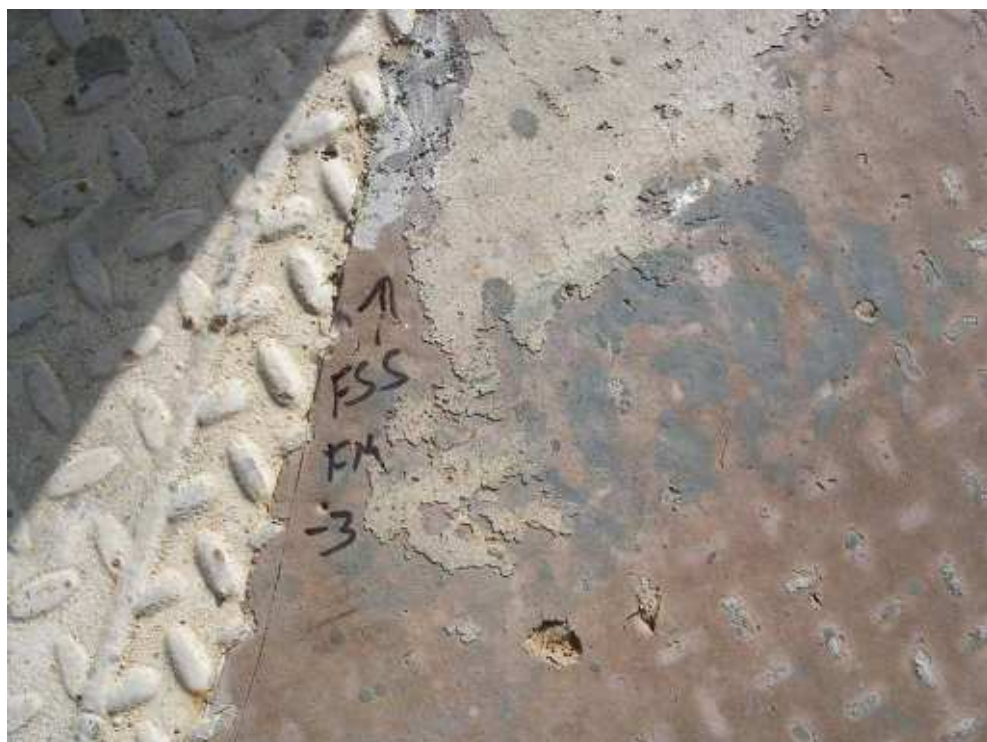
FSS LVL 95'

PROJECT NAME	<u>Launch Complex 39B</u>	Project #:	<u>14005-006-01</u>
INSPECTORS	<u>Javier Du Quesne, Tom Murray</u>		
Project Date:	<u>March 26, 2009</u>	Report Date:	<u>June 2009</u>
Inspection Location:	<u>Launch Complex 39B</u>		
Sample Location:	<u>Fixed Service Structure</u>	Est. Quantity:	<u>126 SF</u>
Homogeneous Area No.:	<u>3</u>	Sample No.:	<u>FM-1, FM-2, FM-3</u>
Material Type:	<u>Miscellaneous Materials (Mastic)</u>		
Description	<u>Pink and Gray Mastic on floor</u>		
% Asbestos:	<u>N/A</u>	Type Asb.:	<u>N/A</u>
Asbestos Response Priority:

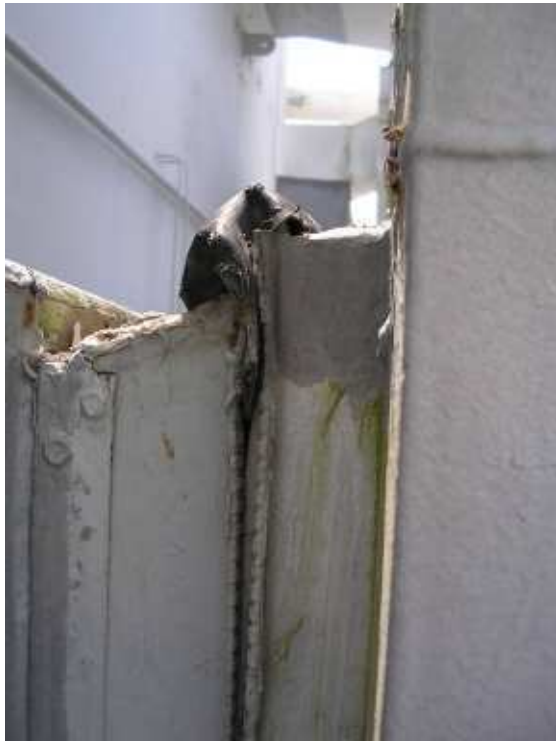
PROJECT NAME	Launch Complex 39B	Project #:	14005-006-01
INSPECTORS	Javier Du Quesne, Tom Murray		
Project Date:	March 26, 2009	Report Date:	June 2009
Inspection Location:	Launch Complex 39B		
Sample Location:	Rotating Service Structure	Est. Quantity:	40 SF
Homogeneous Area No.:	12	Sample No.:	VJC-1, VJC-2
Material Type:	Miscellaneous Materials (Vibration Joint)		
Description	Black Vibration Joint on HVAC		
% Asbestos:	N/A	Type Asb.:	N/A
Asbestos Response Priority:

Present Condition		
Poor (Sign. Damage) >10%	Fair (Damaged) 0-10%	Good (Undamaged) 0%
Friable? <input type="checkbox"/> yes or <input checked="" type="checkbox"/> no		
SKETCH / PHOTOGRAPH NO.:

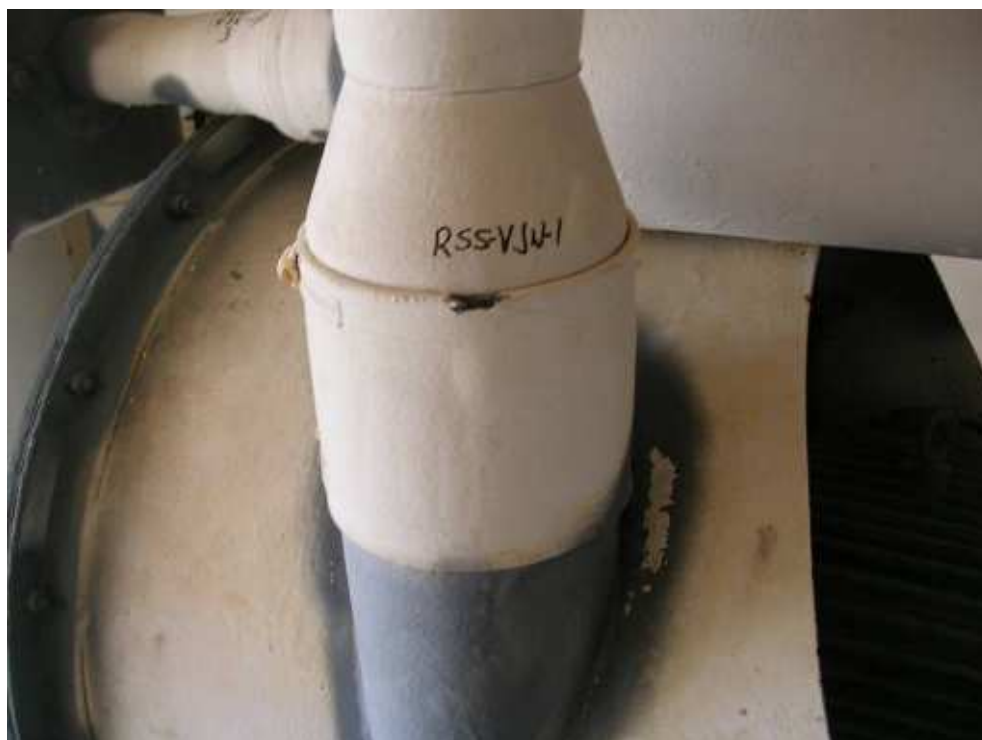
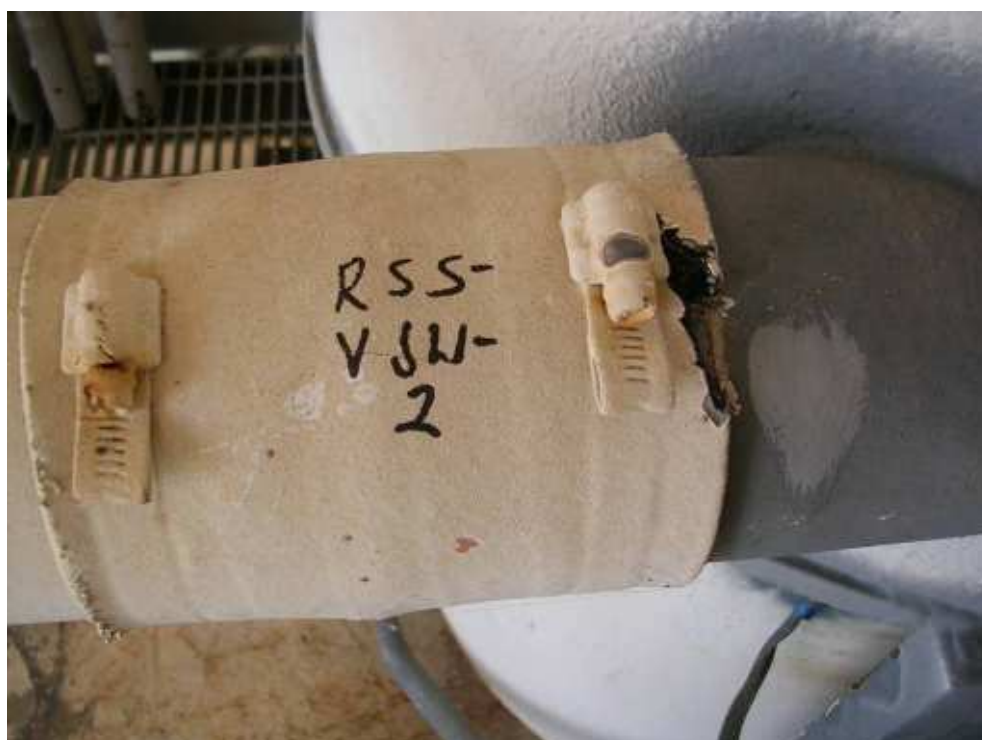
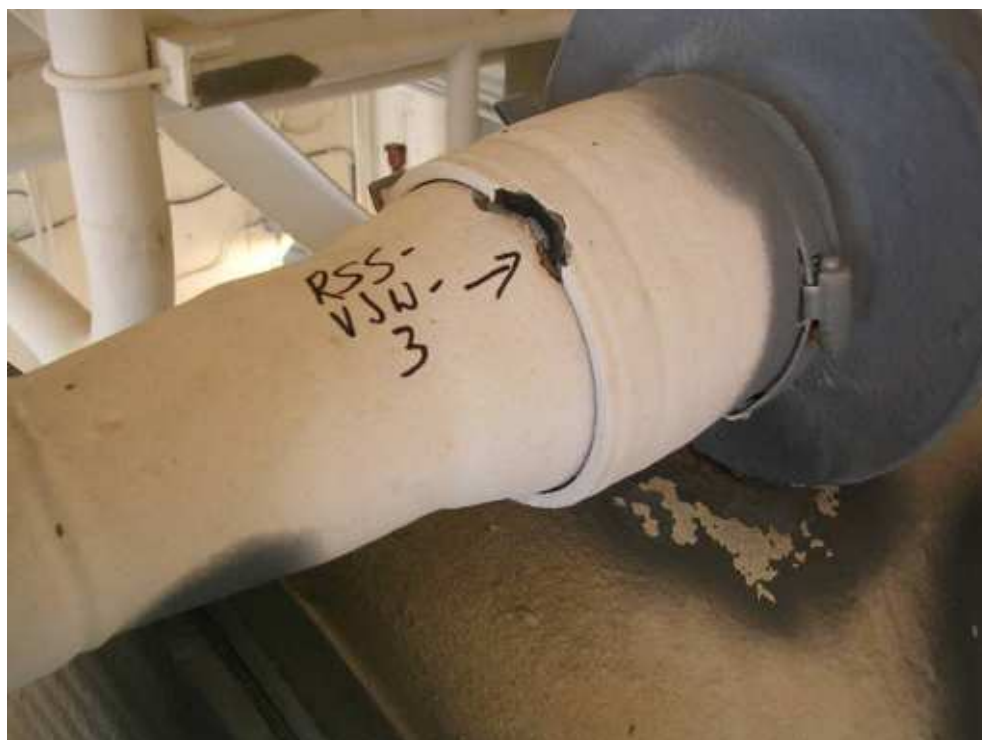
Present Condition		
Poor (Sign. Damage) >10%	Fair (Damaged) 0-10%	<div style="border: 1px solid black; border-radius: 50%; width: 60px; height: 60px; margin: 0 auto; display: flex; align-items: center; justify-content: center;">                         Good (Undamaged) 0%                     </div>
Friable? <input type="checkbox"/> yes or <input checked="" type="checkbox"/> no		
SKETCH / PHOTOGRAPH NO.:

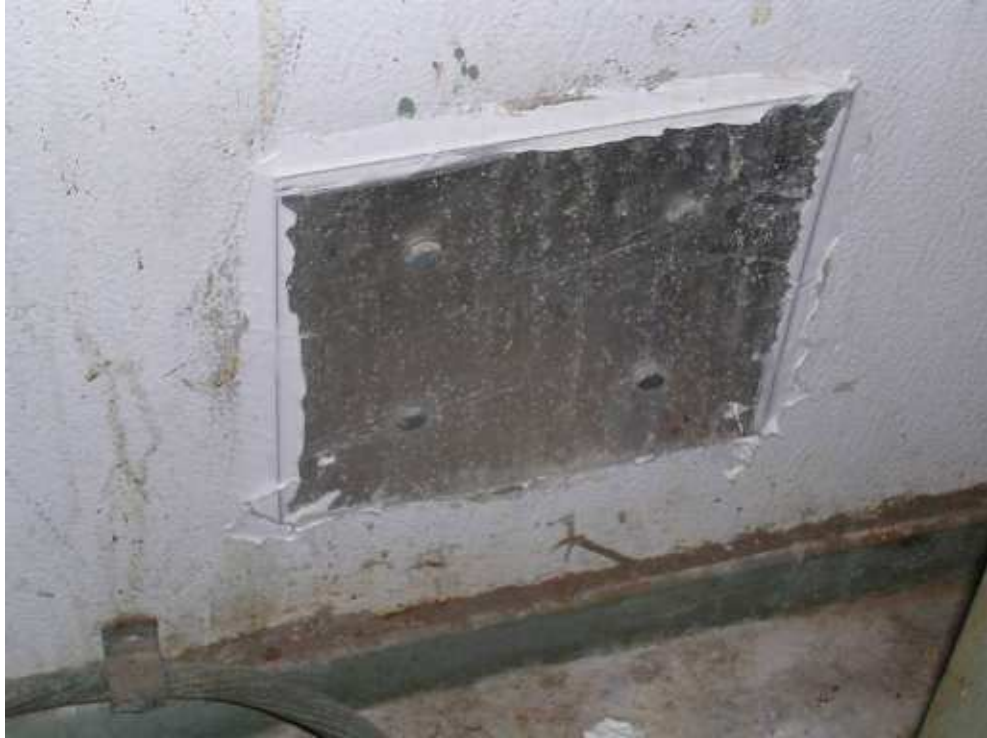
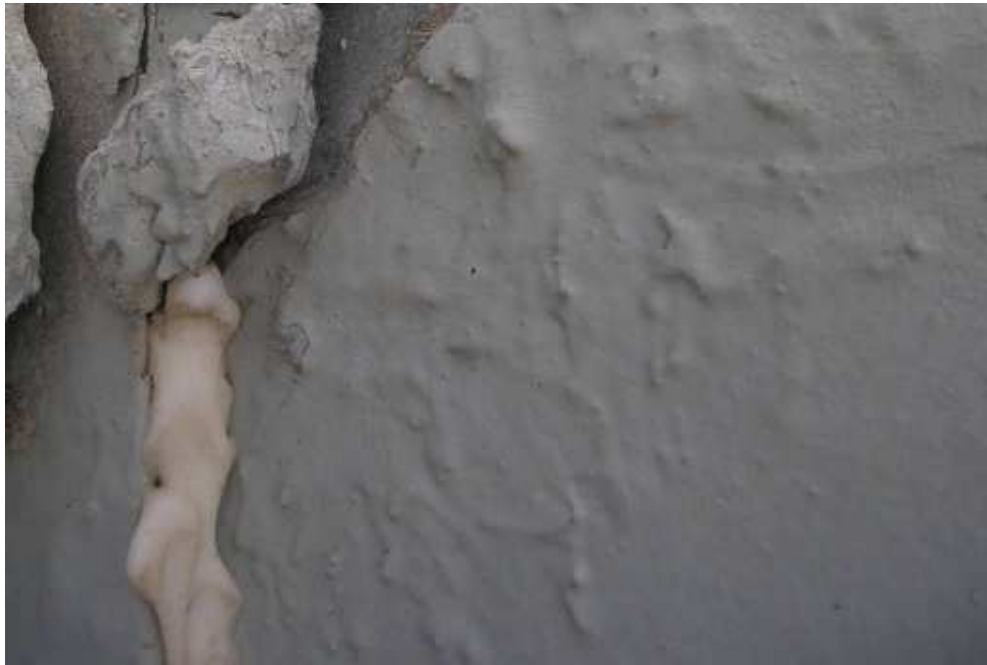
Present Condition		
Poor (Sign. Damage) >10%	<div style="border: 1px solid black; border-radius: 50%; width: 60px; height: 60px; margin: 0 auto; display: flex; align-items: center; justify-content: center;">                         Fair (Damaged) 0-10%                     </div>	Good (Undamaged) 0%
Friable? <input type="checkbox"/> yes or <input checked="" type="checkbox"/> no

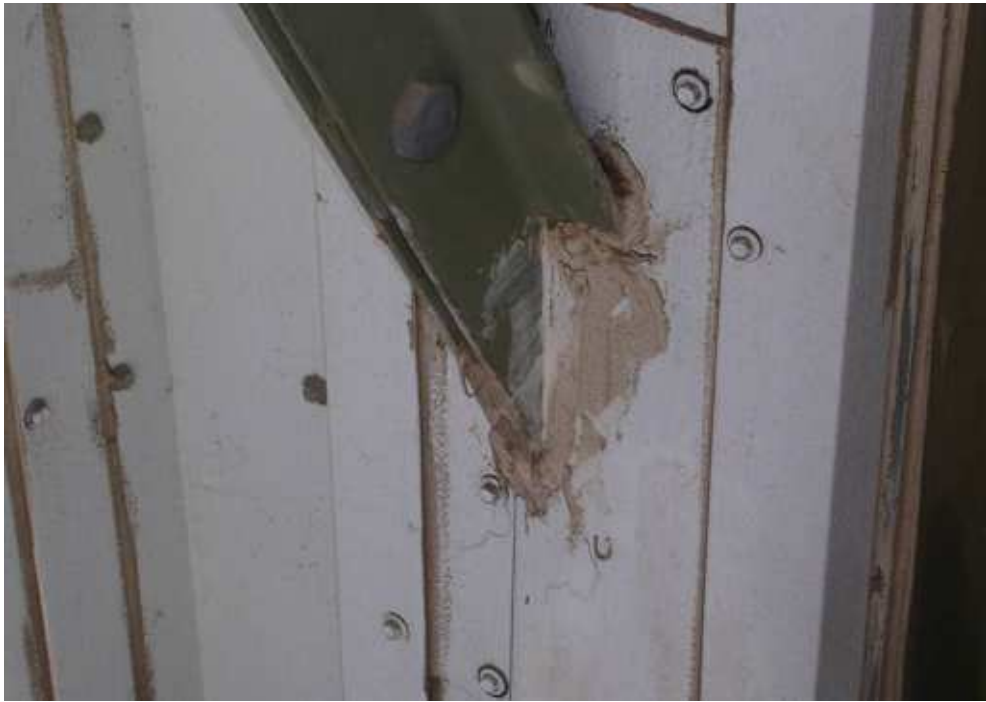
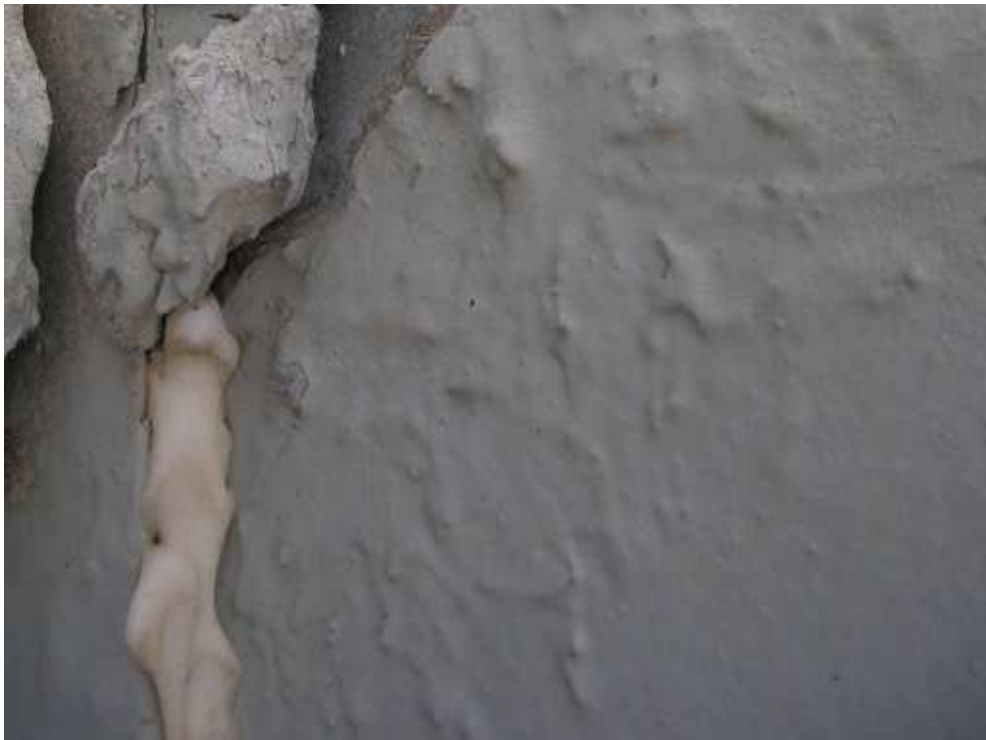
Present Condition		
Poor (Sign. Damage) >10%	<div style="border: 1px solid black; border-radius: 50%; width: 60px; height: 60px; margin: 0 auto; display: flex; align-items: center; justify-content: center;">             Fair (Damaged) 0-10%           </div>	Good (Undamaged) 0%
Friable? <input type="checkbox"/> yes or <input checked="" type="checkbox"/> no

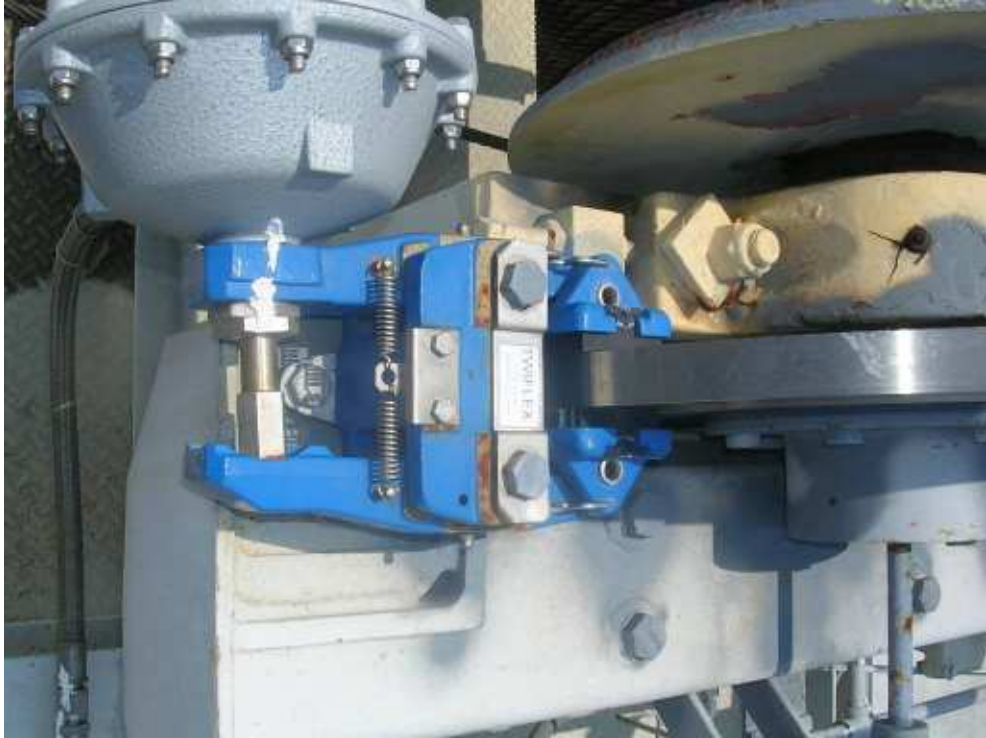
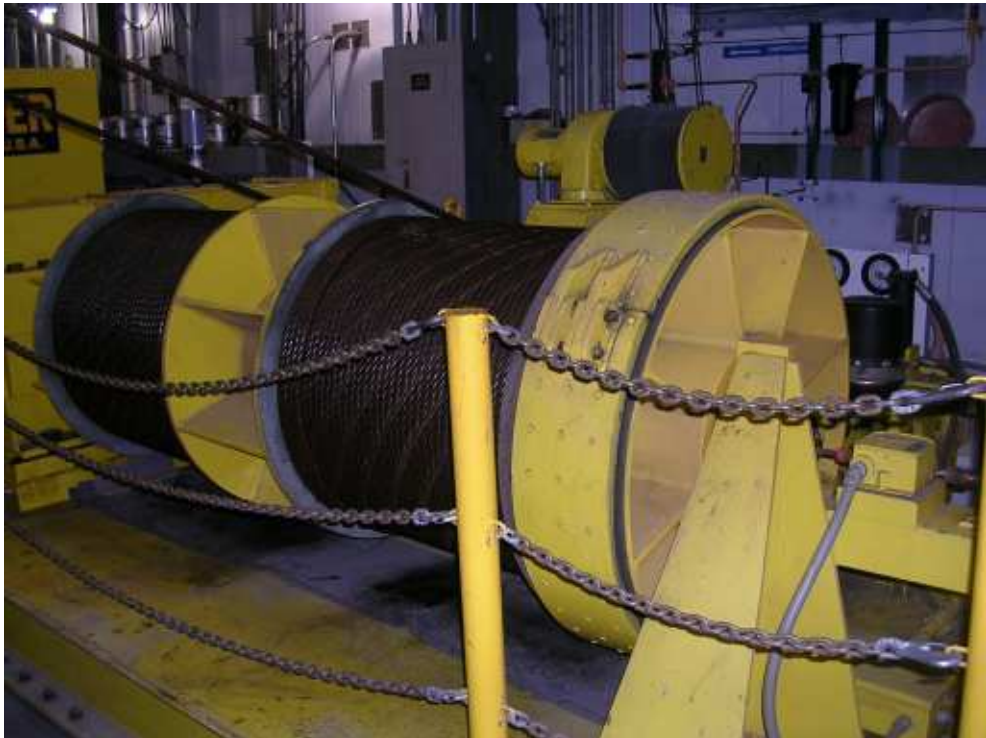
Present Condition		
Poor (Sign. Damage) >10%	Fair (Damaged) 0-10%	<div style="border: 1px solid black; border-radius: 50%; width: 100px; height: 100px; margin: 0 auto; display: flex; align-items: center; justify-content: center;">             Good (Undamaged) 0%           </div>
Friable? <input type="checkbox"/> yes or <input checked="" type="checkbox"/> no
